MSC APOLLO 13 INVESTIGATION TEAM

FINAL REPORT

FLIGHT OPERATIONS
AND NETWORK

APOLLO 13

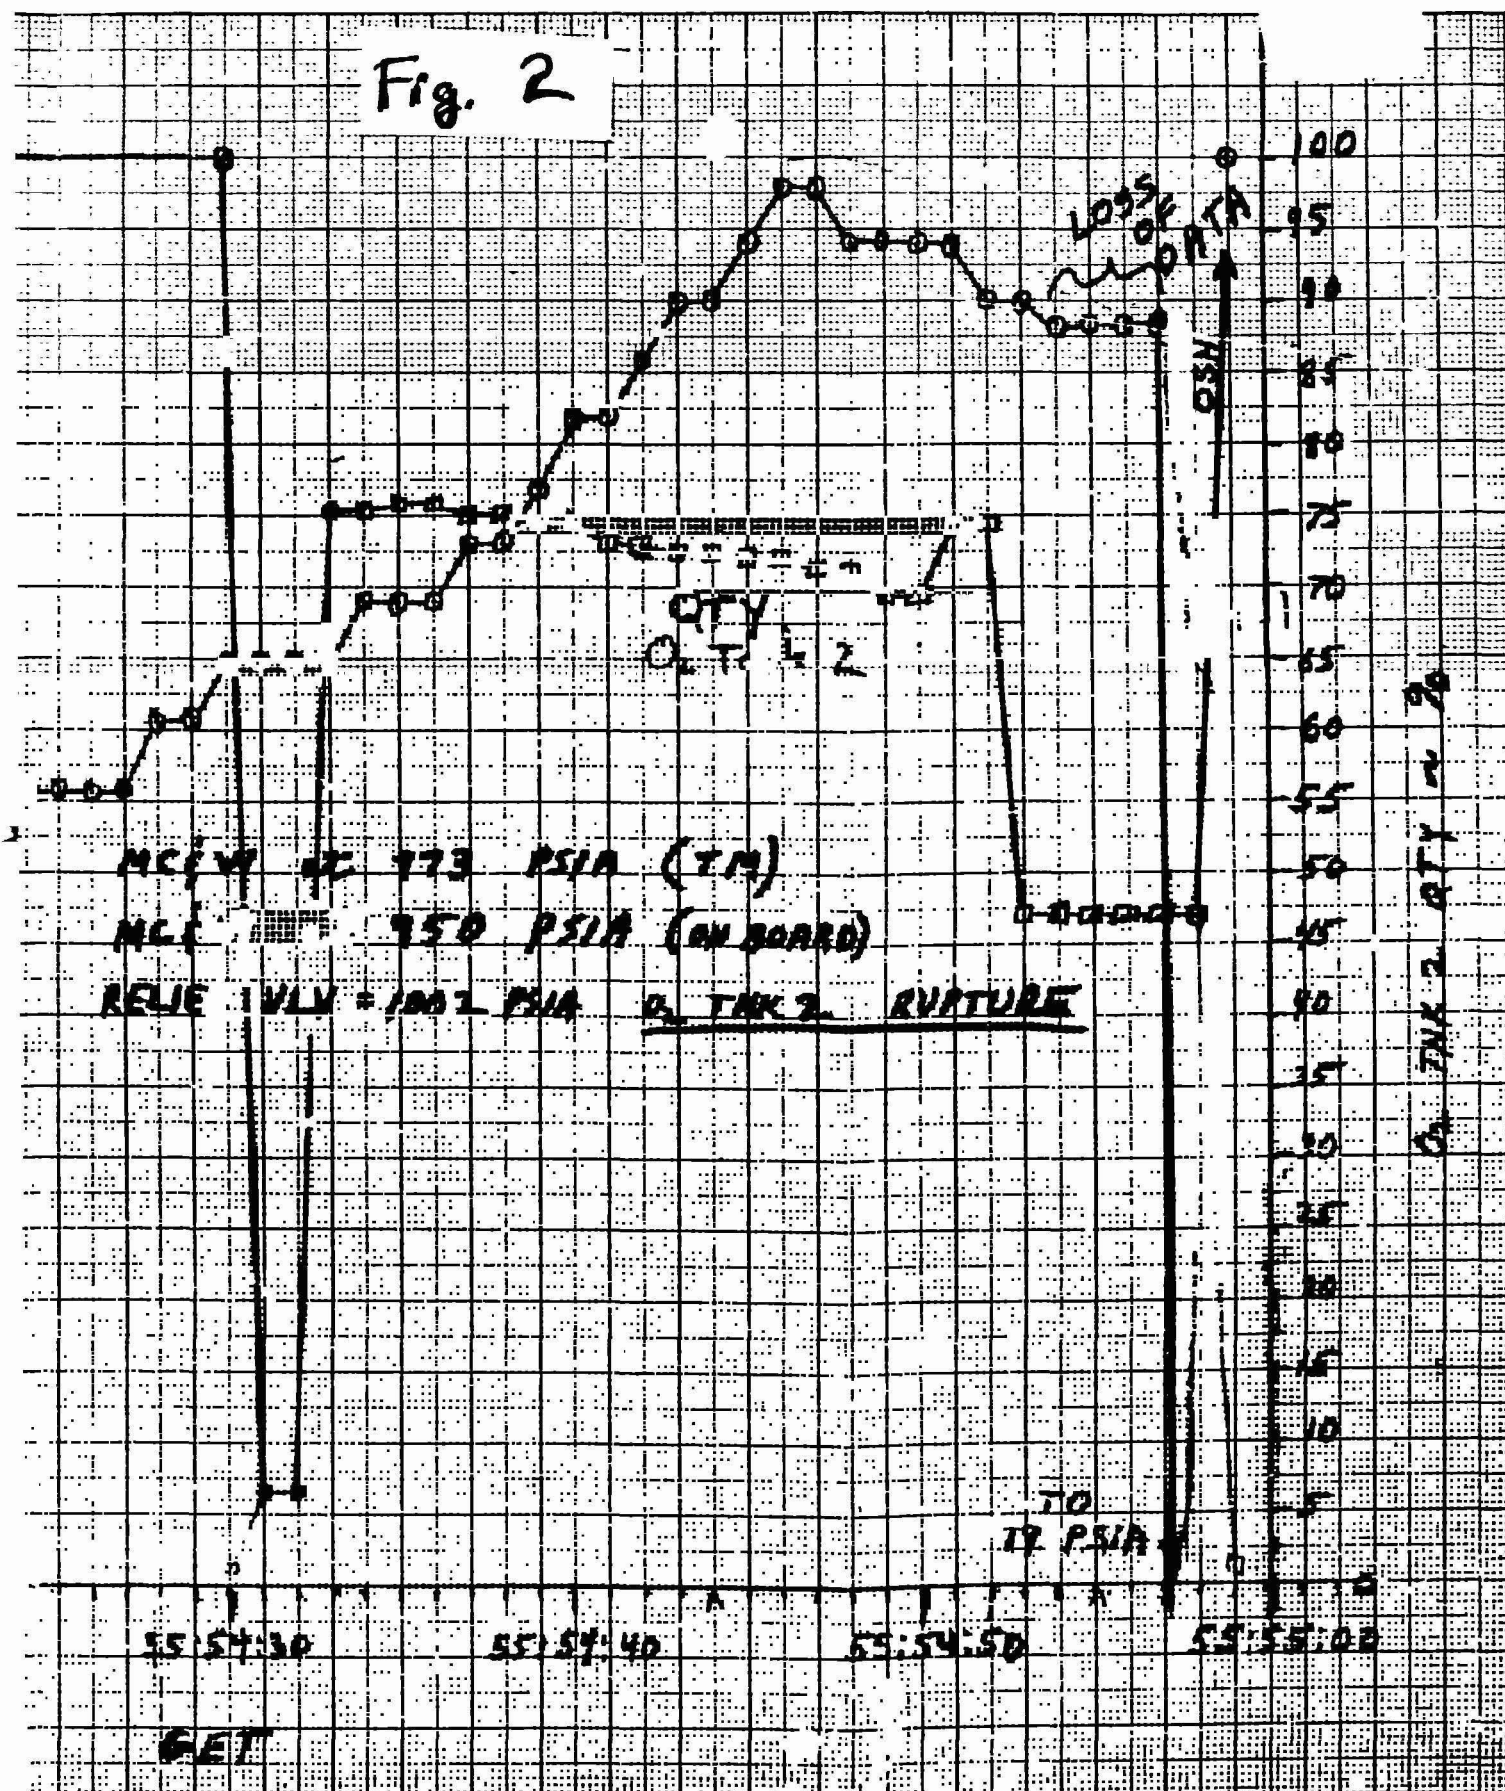
Fig. 2

55:54:31 O2 Tank 2 Qty rose to 75 percent and appeared to give correct readings for approximately 5 seconds before fluctuating again. (See Fig. 2.)

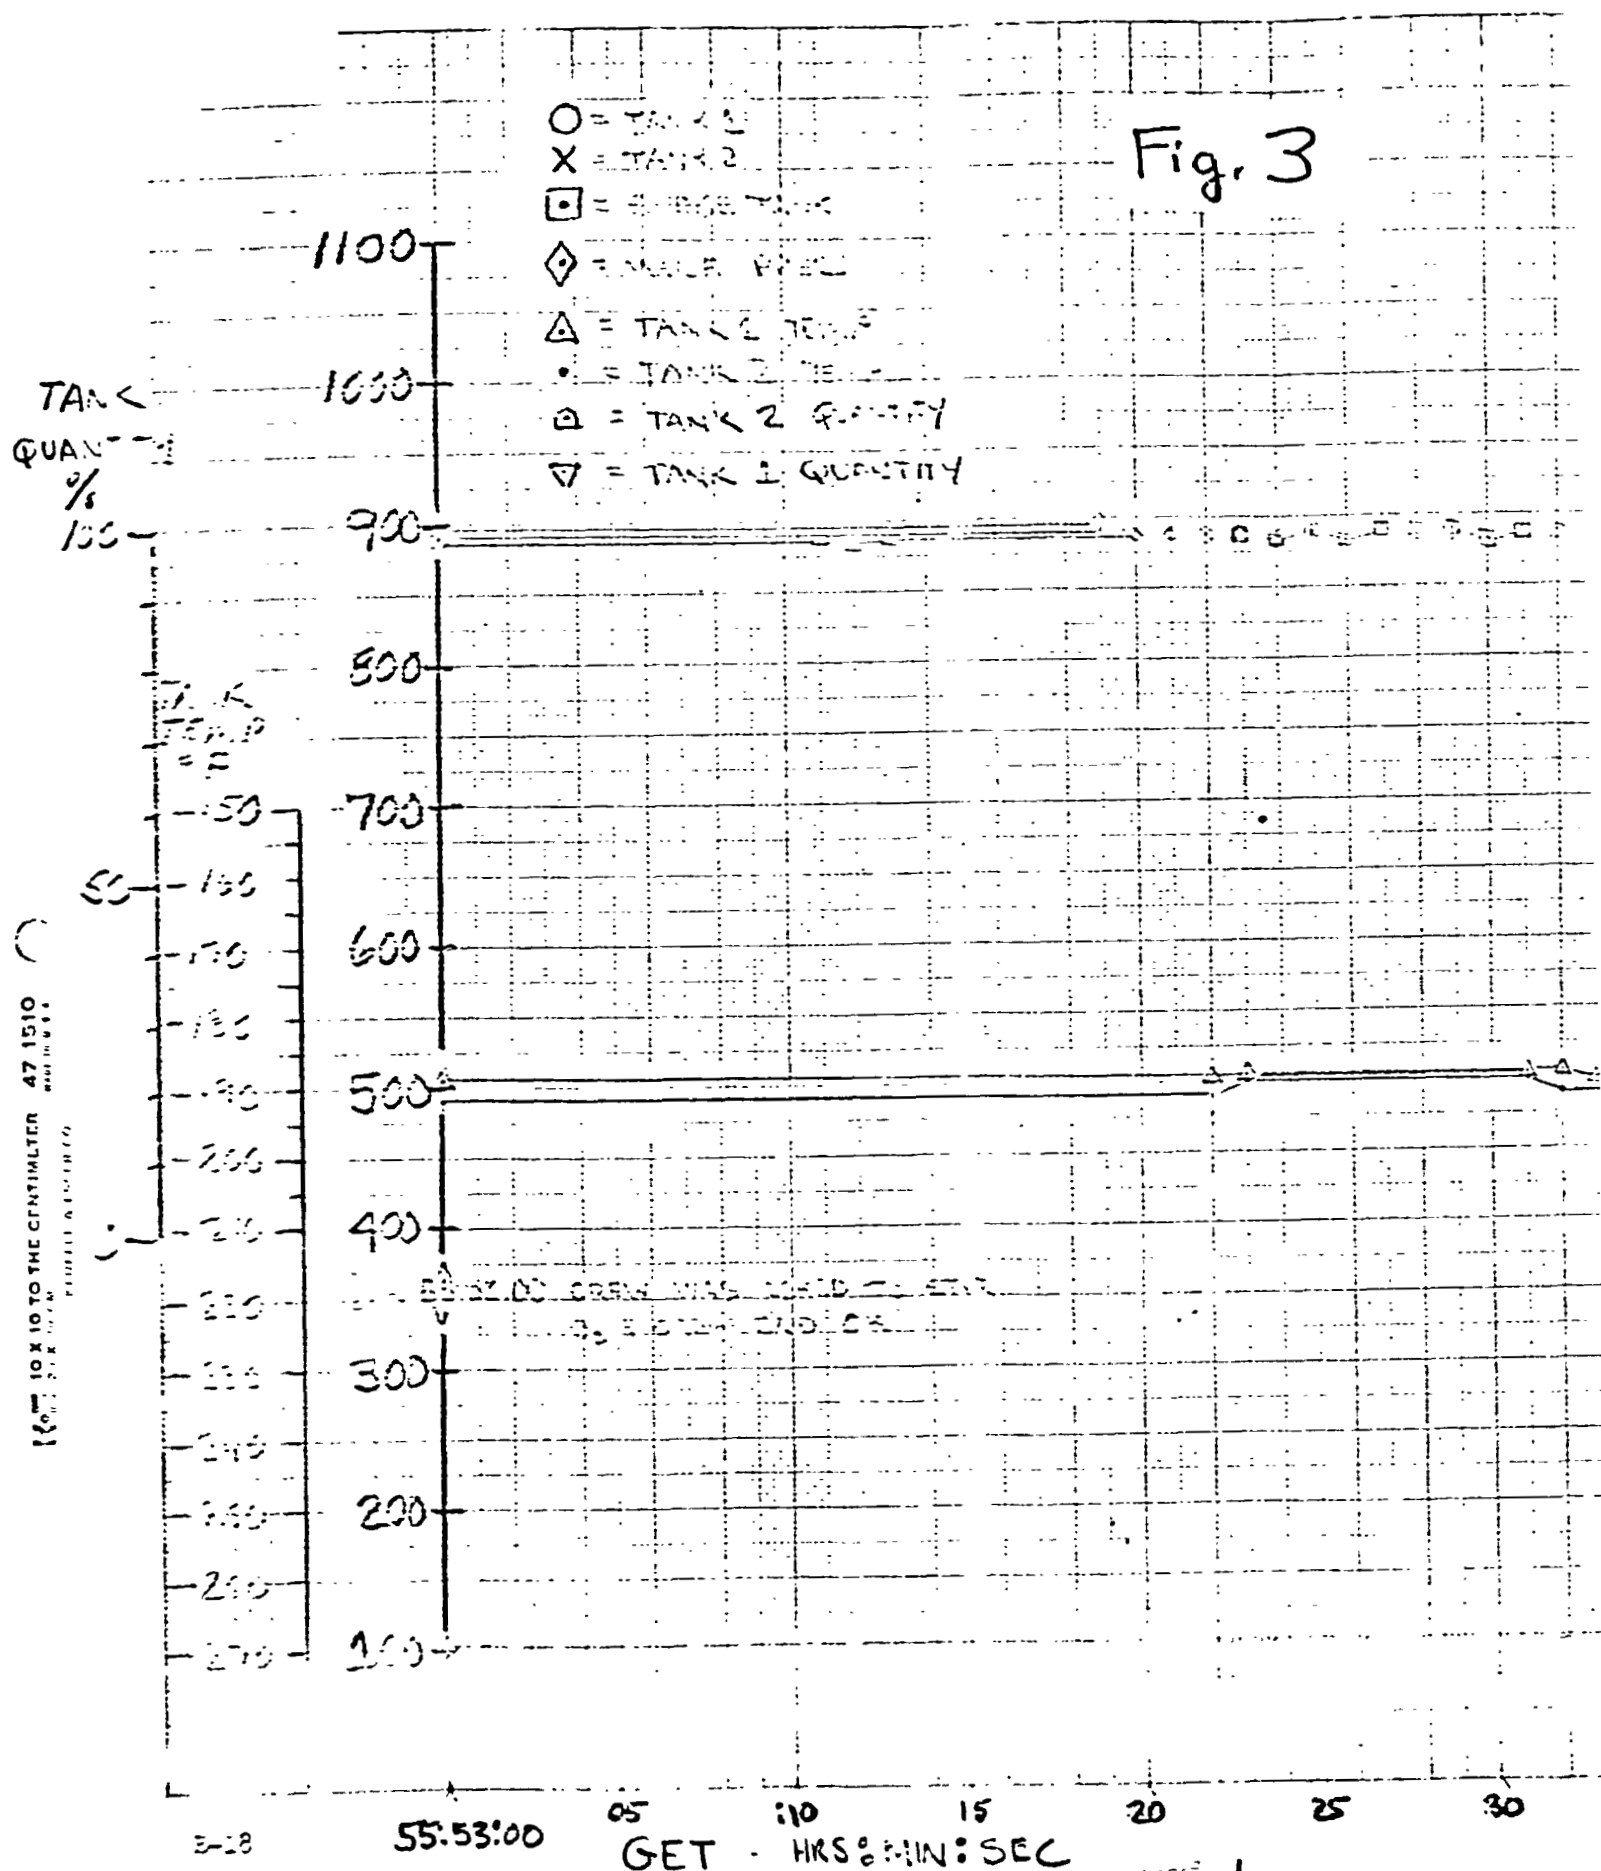
Fig. 3

55:53:35 O2 Tank 2 pressure starts to increase rapidly while O2 Tank 1 remains normal. Tank 2 pressure at this time was 891 psi. (See Fig. 3)

55:54:28 O2 Tank 2 pressure passed through 973 psi with no Hi Cryo Press MC and W. H2 Tank 2 was below its low pressure limit. O2 Tank 2 Qty dropped from 101.17 percent down to 6.5 percent for 3 seconds and the temperature started increasing from -190° F. (See Fig. 3.)

55:54:52 O2 Tank 2 press dropped to 998 psi, indicating possible pressure relieving. Temp had increased to max of -153° F, then dropped off scale low (-329° F.). (See Fig. 3.)

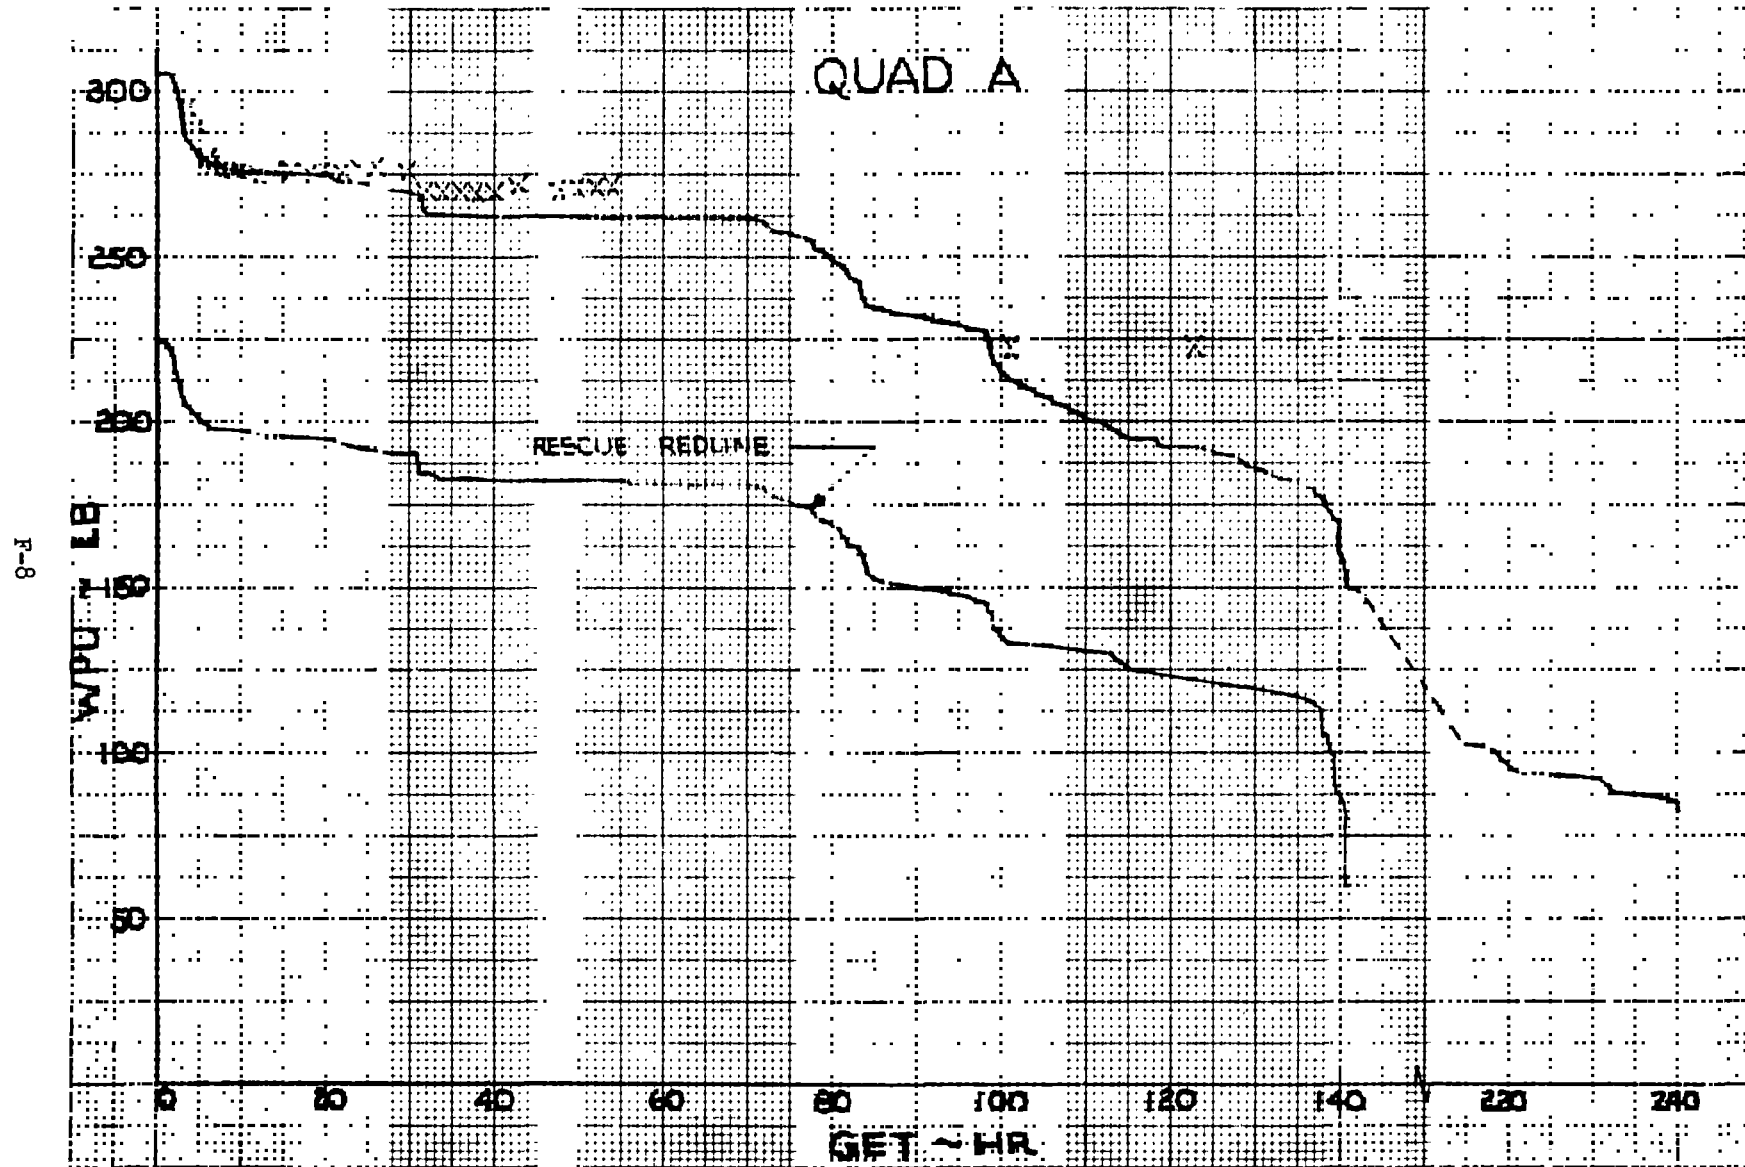
FIGURE 1

Subsequently, the crew reported continued trouble damping the vehicle rates. This was because the DAP had A/C roll selected and the crew had turned off thruster A1. With this configuration \pm Yaw, -Pitch and -Roll was the only control available. There was at this time no indication of Quad C propellant usage forcing the conclusion that either the fuel and oxidizer primary propellant isolation valves were closed or that Quad C was inoperable because of damage. Since both the propellant valves and their talkback indicators required MNB power, the anomaly was left open. The crew subsequently selected B/D roll in the DAP and selected MNA on the RCS jet selects to regain auto control. Figures 1 through 4 show the SMRCS propellant usage on this flight.

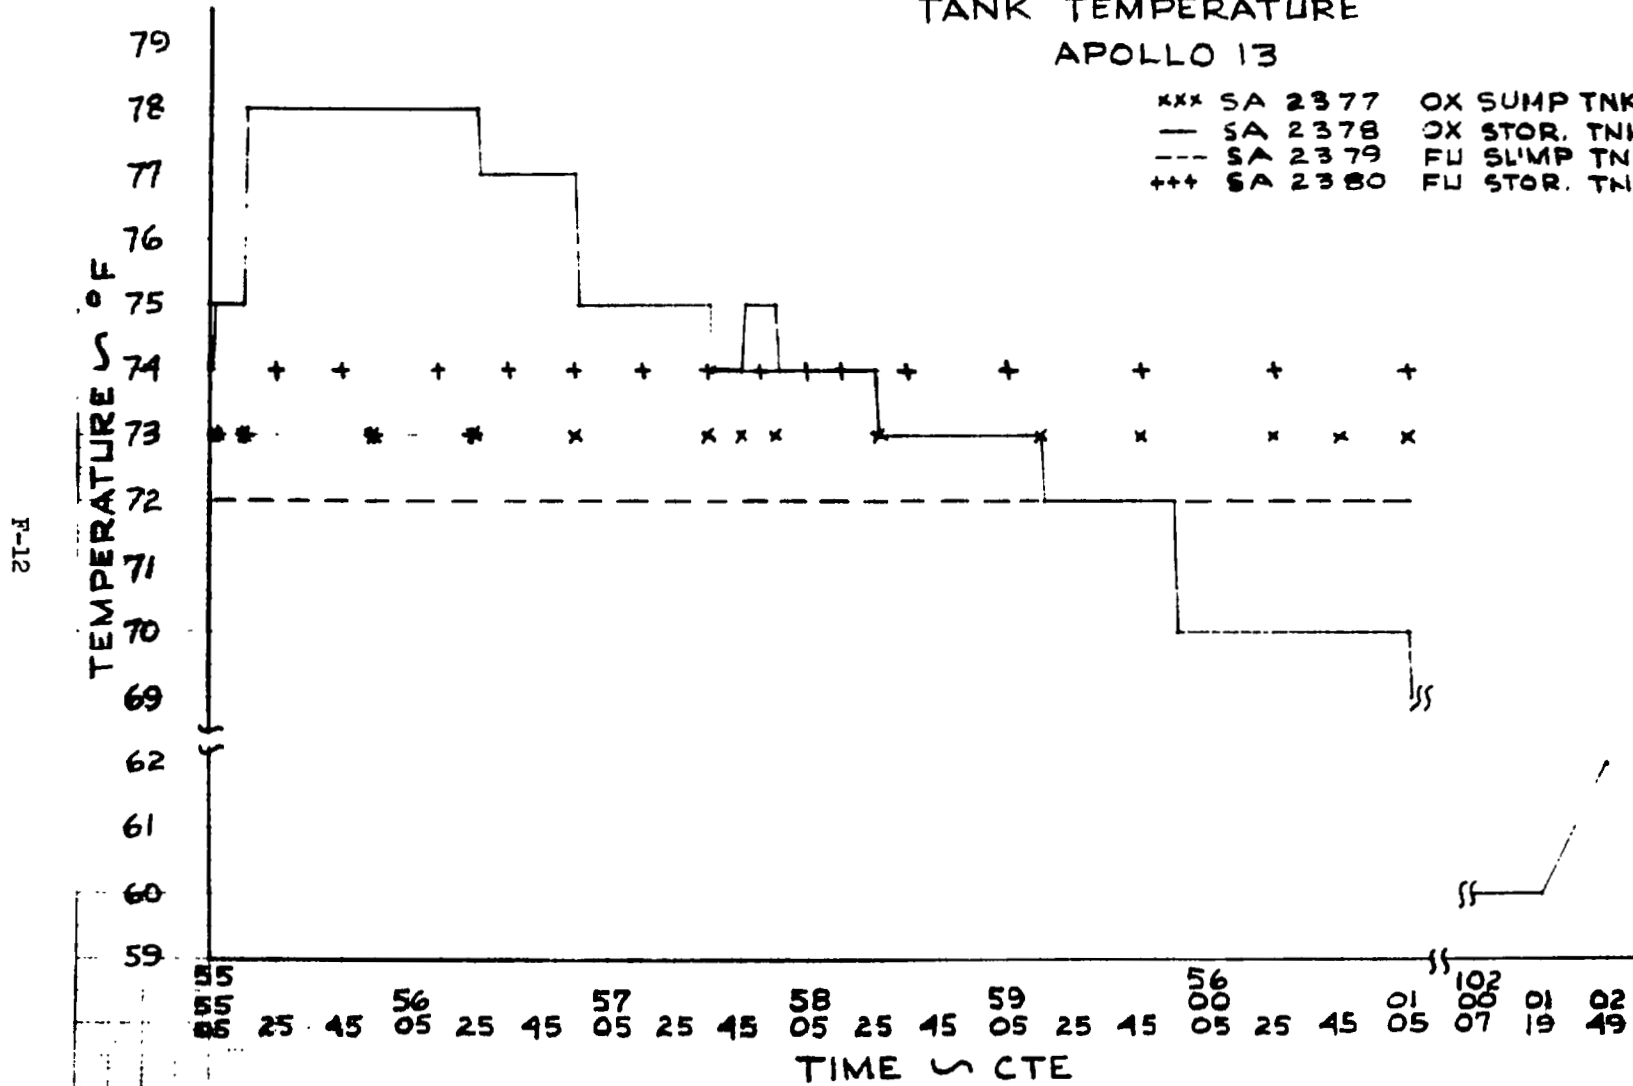
FIGURE 5

3. SPS - There were no SPS anomalies during this flight. Figure 5 is a plot of the propellant tank surface temperatures and shows an interesting but unexplained rise in the temperature sensor located in SM BAY 3. There is no data indicating damage to the SPS as a result of the O2 tank fracture.
